## RESTORATION PLAN

# KENNEDY FLATS

Kootowis, Hospital, Sandhill, Staghorn, Trestle, Trestle S, Indian/Harold, Lostshoe, Salmon

**November 2001**

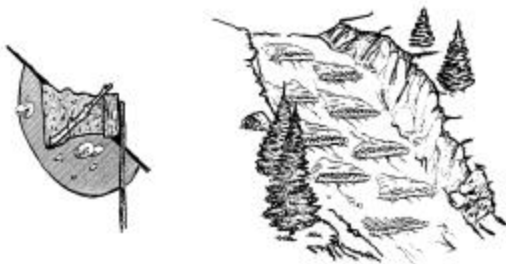
**Figure 4.** Modified Brush Layer (MBL). Dormant willow cuttings are used to build living, self maintaining, retaining walls on land slides. Willow is used because the cuttings grow roots where exposed to soil, and shoots where exposed to air

Grass establishes well on areas of a slide that are relatively stable. Zones of instability are identified the following year by observation of areas of poor grass establishment. Following the deactivation of the roads there is a focus on restoring the unstable portions of the landslides. To stabilize and revegetate the slides an approach called bio-engineering is utilized. Basically this is the use of live willow cuttings to hand build living, self-maintaining, retaining walls.
